DEPARTMENT OF TRANSPORTATION**DIVISION OF ENGINEERING SERVICES**

Contract #: 04-0120F4Cty: SF/ALA Rte: 80 PM: 13.2/13.9File #: 1.28**WELDING INSPECTION REPORT****Resident Engineer:** Siegenthaler, Peter**Address:** 333 Burma Road**City:** Oakland, CA 94607**Report No:** WIR-018481**Date Inspected:** 02-Dec-2010**Project Name:** SAS Superstructure**OSM Arrival Time:** 700**Prime Contractor:** American Bridge/Fluor Enterprises, a JV**OSM Departure Time:** 1100**Contractor:** American Bridge/Fluor Enterprises, a JV**Location:** Job Site**CWI Name:** John Pagliero**CWI Present:** Yes No**Inspected CWI report:** Yes No N/A**Rod Oven in Use:** Yes No N/A**Electrode to specification:** Yes No N/A**Weld Procedures Followed:** Yes No N/A**Qualified Welders:** Yes No N/A**Verified Joint Fit-up:** Yes No N/A**Approved Drawings:** Yes No N/A**Approved WPS:** Yes No N/A**Delayed / Cancelled:** Yes No N/A**Bridge No:** 34-0006**Component:** OBG Section**Summary of Items Observed:**

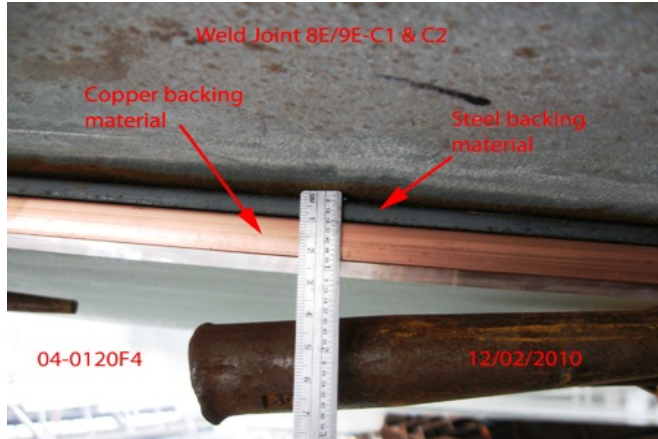
At weld joint 8E/9E – C-1 & 2 and E-1 & 2, outside the OBG section this QA Inspector observed ABF personnel have fit up a 9 mm (3/8-inch) steel backing bar which is covered with a 12 mm (1/2-inch) copper bar. See photos below.
